EXHIBIT 3

RE: Church of the Most Holy Redeemer - Basement

MATERIALS ANALYTICAL SERVICES, INC.
PLM ANALYSIS

MINERAL ANALYSIS SHEET

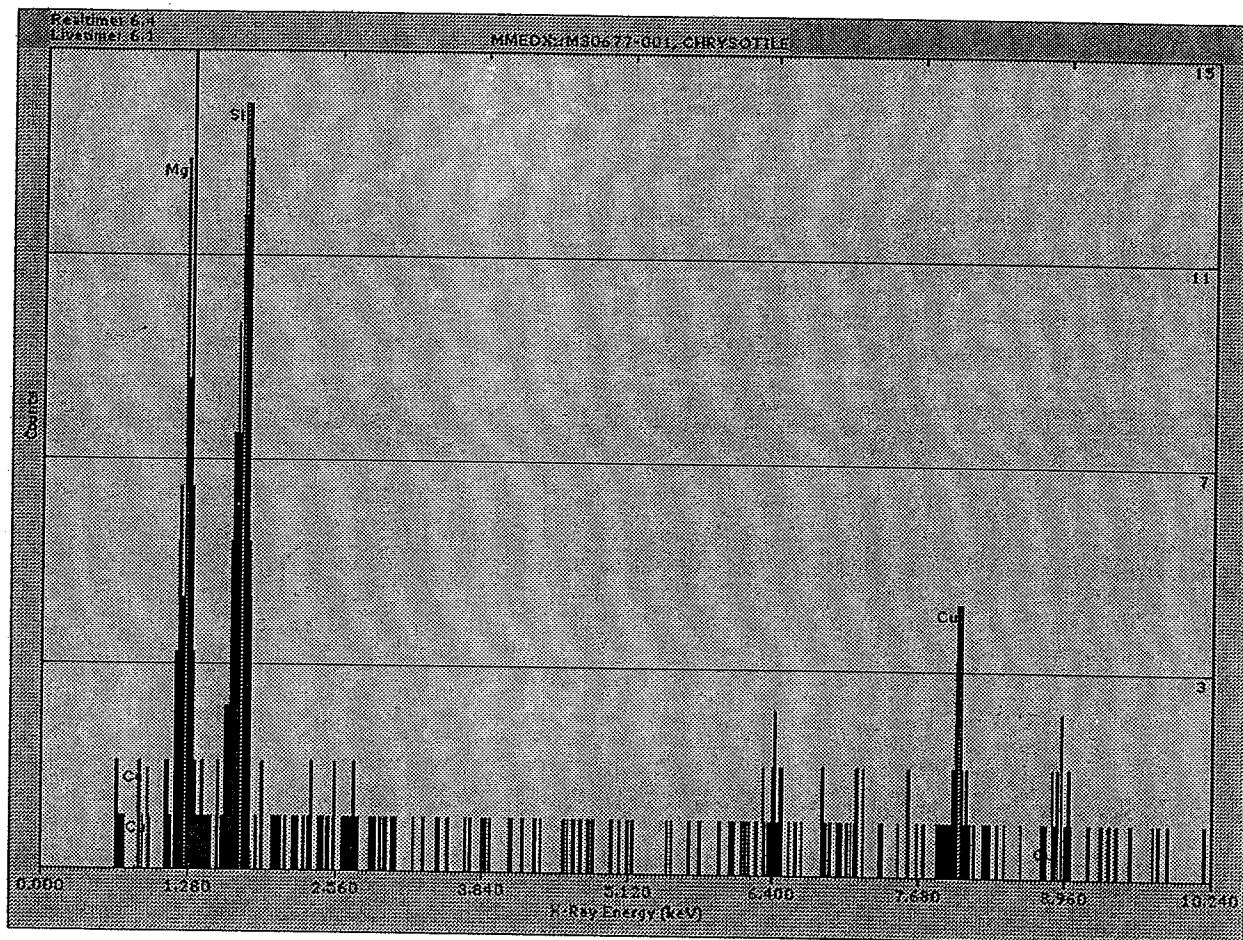
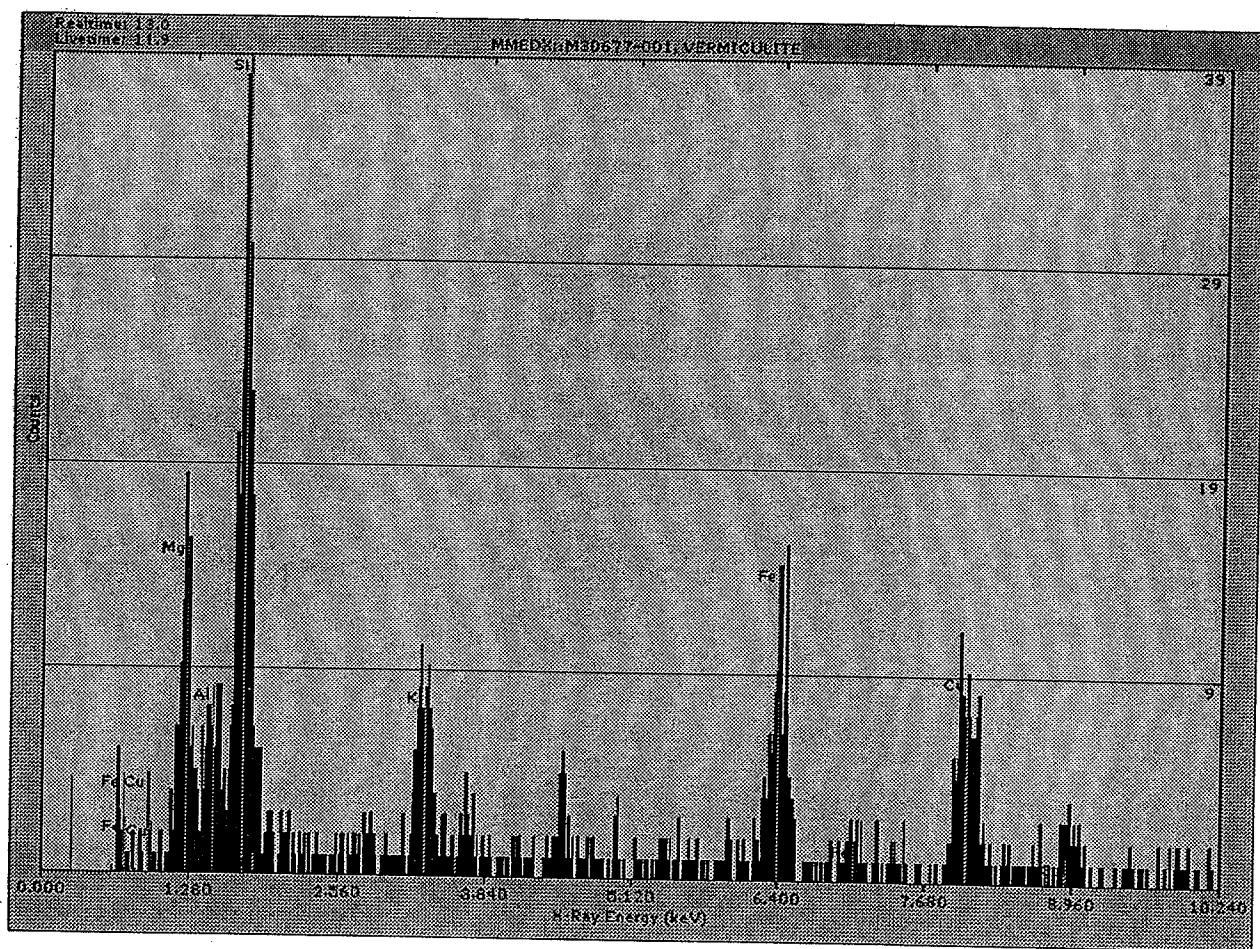
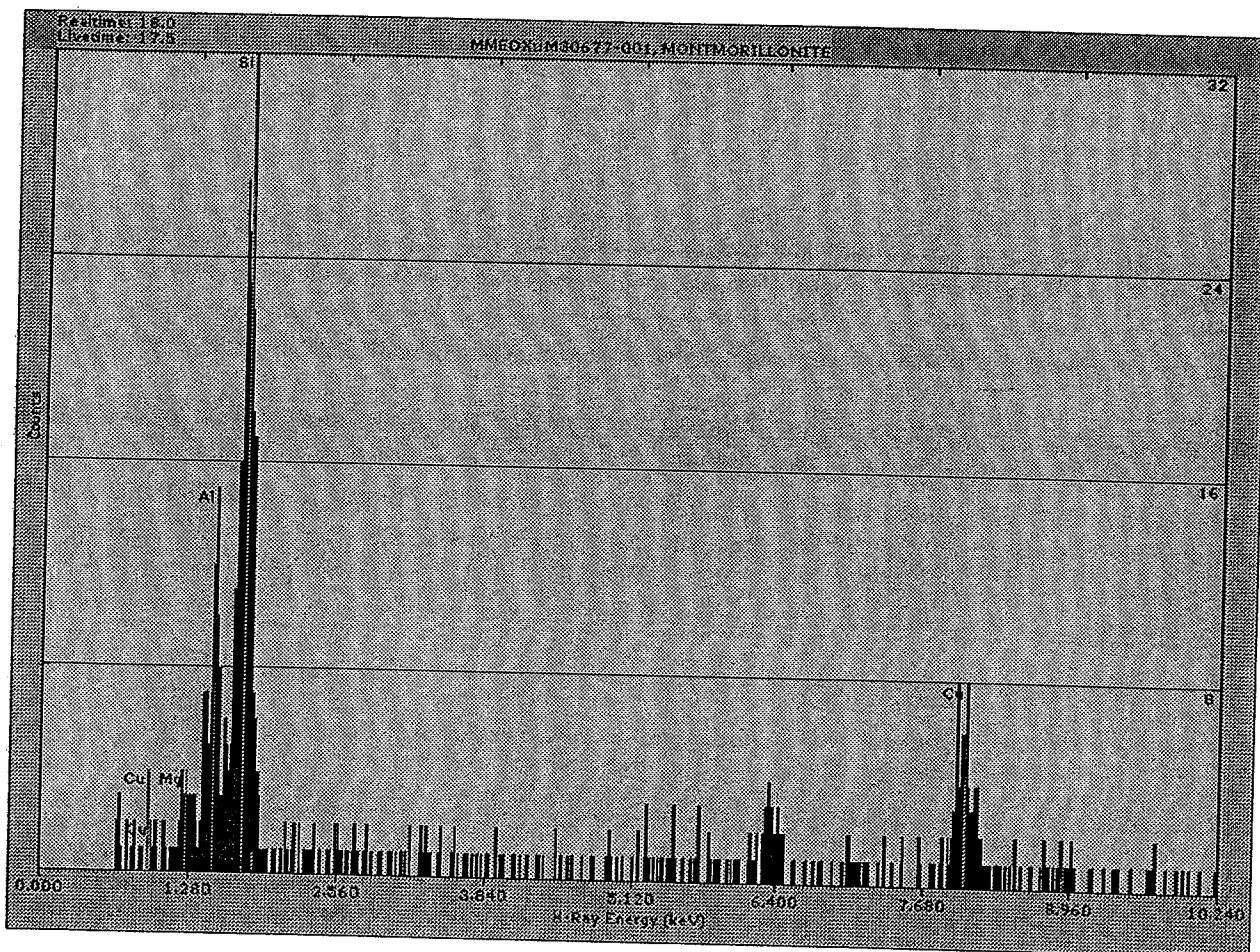
ITEM ANALYSIS: BULK ANALYSIS
PROJECT: CHURCH OF THE HOLY REDEEMER
SAMPLE NUMBER: 17306778-001
SAMPLE ID: 1
DATE OF ANALYSIS: 3/20/03
ANALYST: L.A. Sch

Morphology	Wavy		
Pleochroism	None		
Refract Index	1.555/1.548		
Sign	+		
Extinction	Parallel		
Birefringence	Low		
Melt	No		
Fiber Name	Chrysotile

Chrysotile.....	15
Amosite.....	
Crocidolite.....	
Tremolite/Actinolite.....	
Anthophyllite.....

Vermiculite	70
.....
.....
.....
Binder	15
